Certificate of Substantial Completion

PROJECT: (name and address) HCSB/Springstead H.S. Bldgs. 7, 8, & 9 3300 Mariner Boulevard Spring Hill, Florida 34609	CONTRACT INFORMATION: Contract For: Roof and Mechanical Equipment Replacement Date: March 10 th , 2022	CERTIFICATE INFORMATION: Certificate Number: 001 Date: July 17th, 2024
OWNER: (name and address) Hernando County School District 8008 Mobley Road Brooksville, Florida 34601	ARCHITECT: (name and address) A/R/C Associates, Incorporated 601 North Fern Creek Avenue, Suite 100 Orlando, Florida 32803-4899	CONTRACTOR: (name and address) Ryman Roofing, Incorporated 36413 State Road 54 Zephyrhills, Florida 33541

Project:	Frank W. Springstead High School Roof and Mechanical Equipment Replacement of Buildings 7, 8 and 9	A/R/C Project No.:	21009.00
Client:	Hernando County School District	Site Visit Report No.:	18
Contractor:	Ryman Roofing, Inc.	Date:	2024-07-09
Report By:	Randy Barton, Quality Assurance Representative	Weather:	Rain - 85 °
Present:	Randy Barton, A/R/C Associates Ian Hord, Matern Engineering	Desmond Maner, HCSB Aaron Camacho, Ryman Roofing

HCPS Springstead HS HVAC Replacement

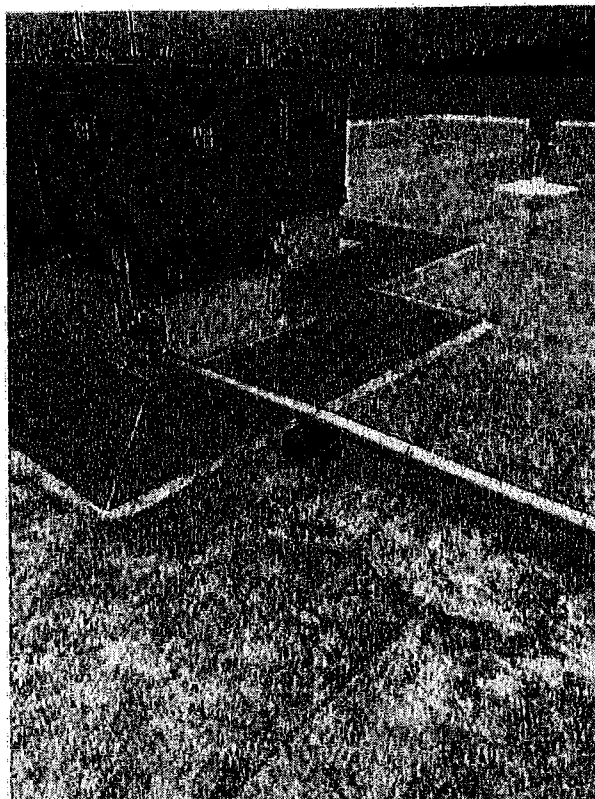
1. Label all condensate lines. Typical throughout project.
2. Provide specified labels.
3. Provide equipment labels for all RTUs. Typical throughout project.
4. Coil drains and vent shall be red brass nipples refer to contract documents. Typical for all RTUs.

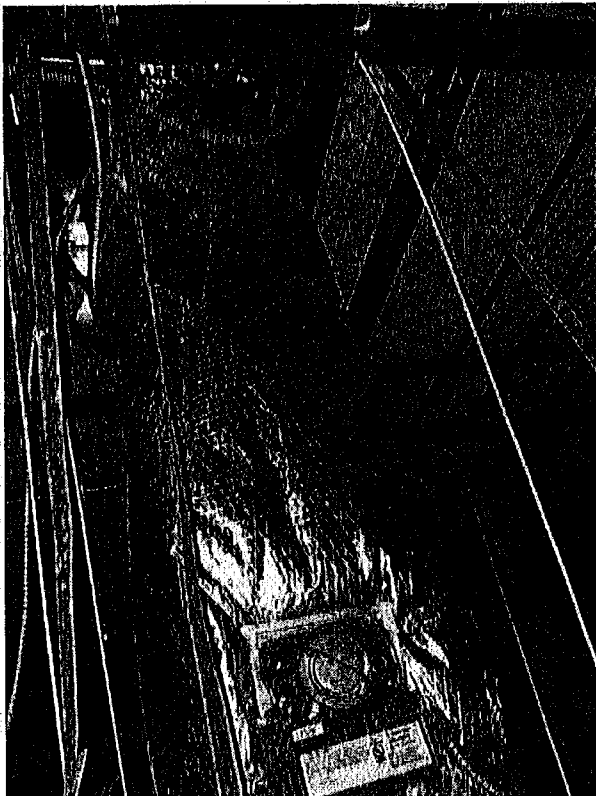
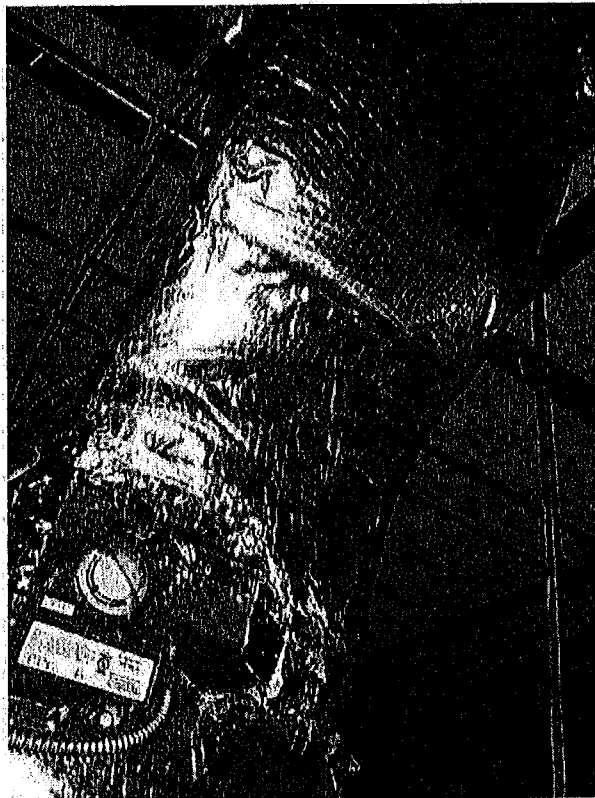
1. Provide staples fab and mastic at all insulation joints. Typical throughout project.

2. Provide insulation around smoke detectors.
